**Subject:** **REHABILITATION OF THE 63RD STREET BRIDGE, CONSTRUCTION OF  
AT-GRADE INTERSECTION AT 63RD STREET AND INDIAN CREEK  
DRIVE, AND RECONSTRUCTION OF INDIAN CREEK DRIVE FROM 63RD  
STREET TO ABBOTT AVENUE**

**Abbreviated Inspection Report**

**N.W. 63<sup>rd</sup> Street Bascule Bridge**

**Indian Creek Canal**

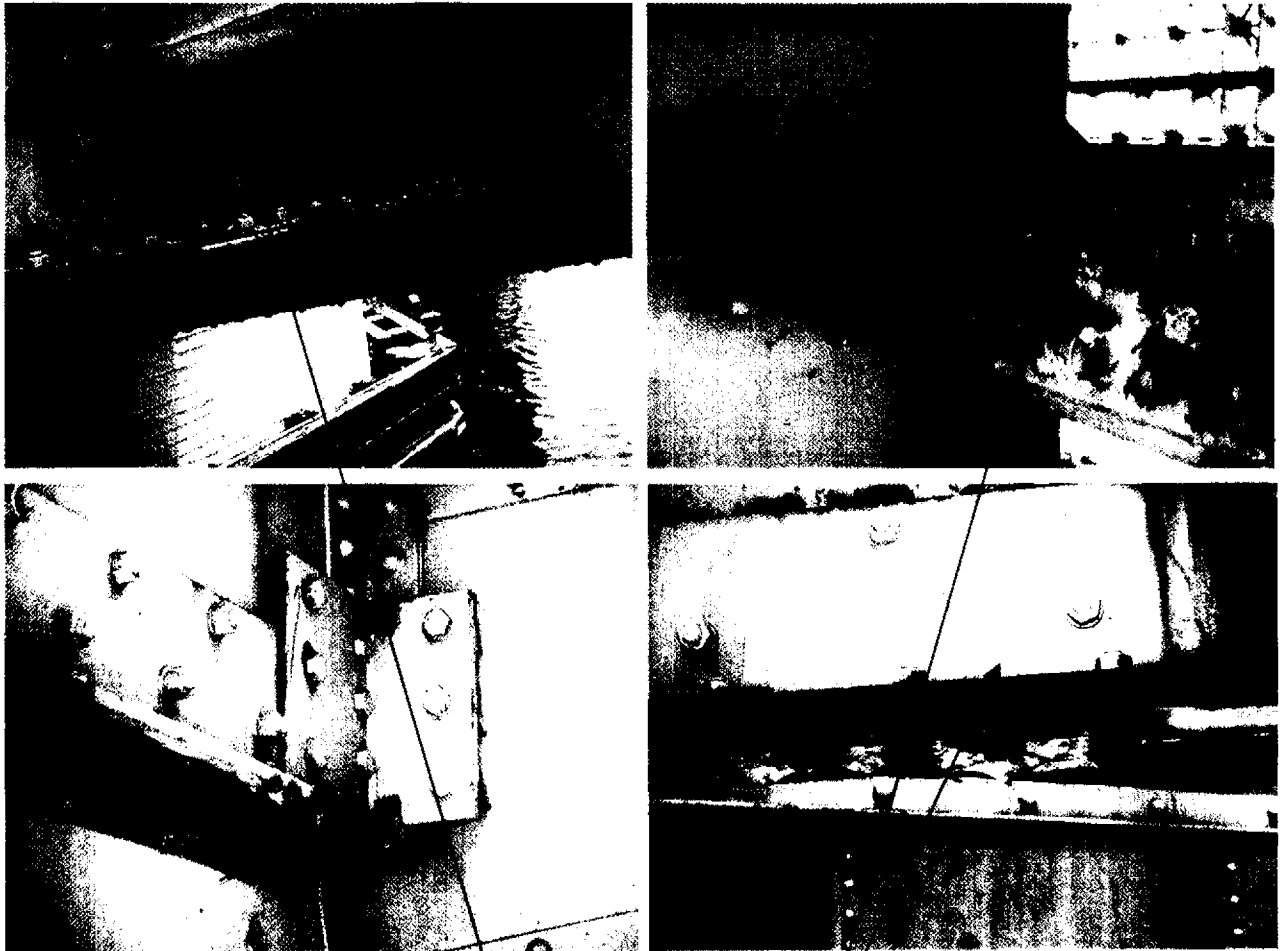
**FLOOR BEAM 2**

Member was cover plated in 1988 to repair badly corroded top and bottom flanges. Cover plates have also become badly corroded.

Take bridge out of service and replace beams in all 4 locations or take bridge out of service and replace all cover plates in all 4 locations to strengthen.

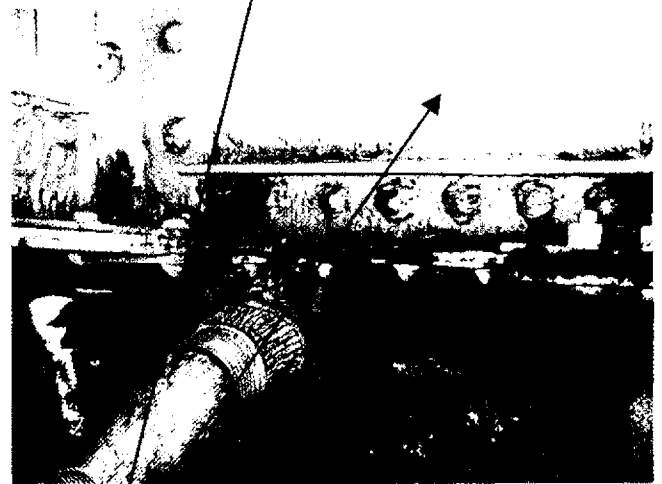
### FLOOR BEAM 3

Member was cover plated and repaired in 1988 to correct badly corroded top and bottom flanges. Cover plates and repairs have now also become badly corroded.

Take bridge out of service and replace beams in 4 locations.

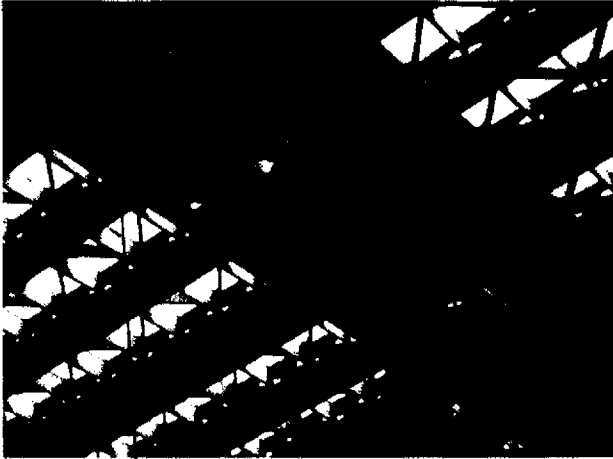
### STRINGERS BETWEEN FLOOR BEAM 1 AND FLOOR BEAM 3

In General these members are in good condition. There are however, three stringers that have sufficient corrosion to warrant their replacement.

Clean and paint all stringers that are in good condition and replace the three stringers mentioned above.

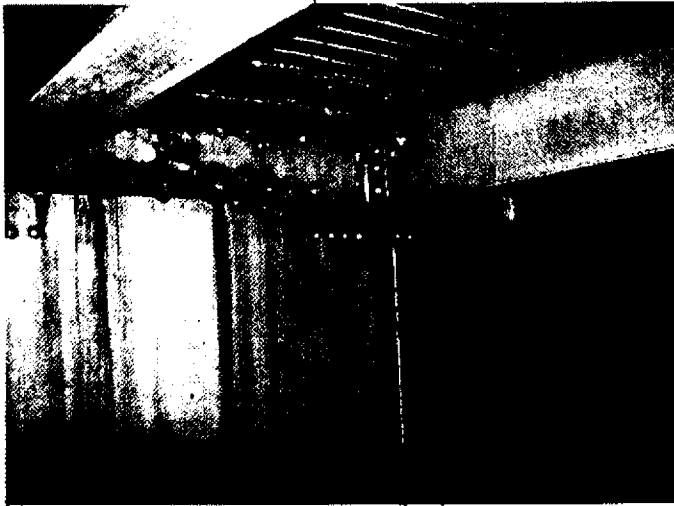
**COUNTERWEIGHT GIRDER 1**

The top flanges of these girders was repaired in 1988 and these repairs are now corroded. The top flange and the repairs support the concrete filled grating, which as noted above is recommended to be replaced.

Take Bridge out of service and remove and replace top flange repairs of counterweight girders 1

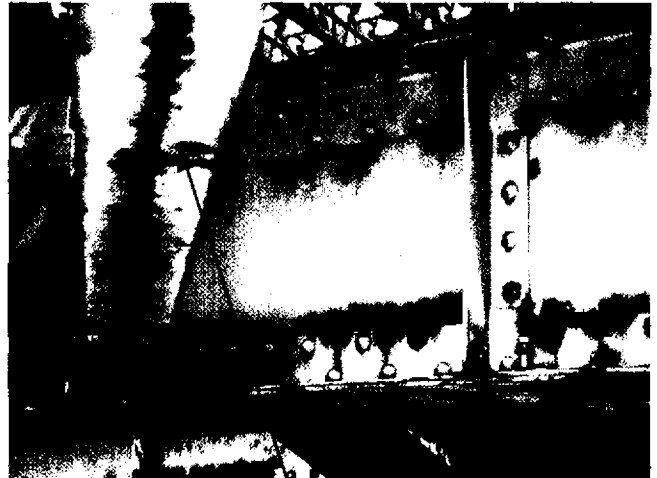
**CROSS BRACING and GUSSET PLATES**

Diagonal bracing members are made up of back-to-back angles and have slight to moderate corrosion. Almost all bracing members exhibit severe corrosion along the joint between angles. .

Removed and replace these members with structural tee sections

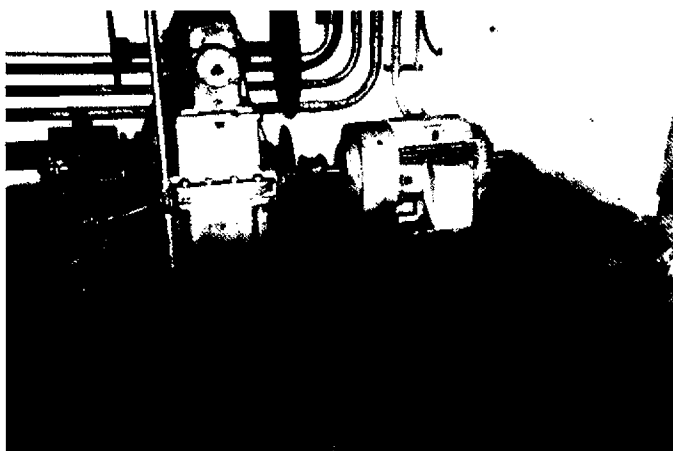
The recently installed 20 HP motors are twice as powerful as the original 10 HP motors and subject the machinery to potential overstress. AASHTO operating horsepower requirement calculations justify the need for 20 HP motors, but the existing machinery was designed for 10 HP motors.

Each leaf originally had a motor and a machinery brake. The motor brakes were removed from each leaf when the 20 HP motors were installed. The remaining machinery brakes were in poor condition and may not stop or hold the leaves in an emergency stop or high wind condition.

Take bridge out of service and replace all of the existing machinery. The system should provided a means of load sharing. Provide new span lock and tail locks.

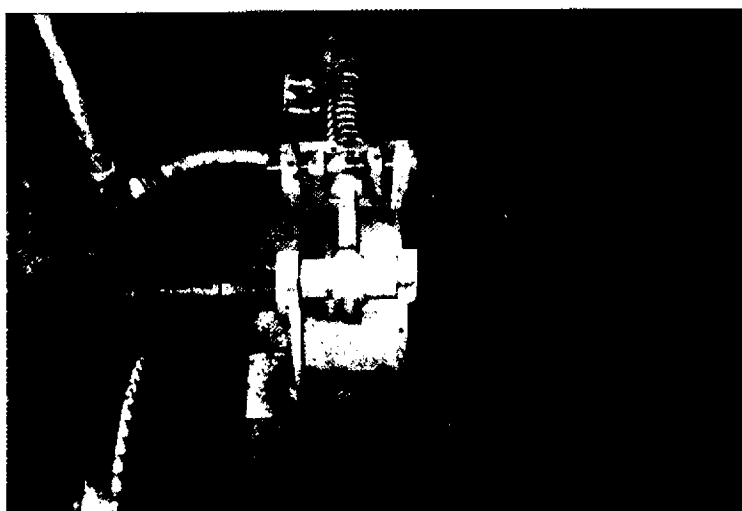
The leaves bounced excessively under live load due to excessive span lock clearance, improper seating of the leaves on the live load shoes, and the removal of the tail locks. The connection between the end floor beam and span lock support beam was loose at the extreme north span lock.
